ROCKAWAY BEACH WWTF
Rockaway Beach, MO.

September 13, 2007

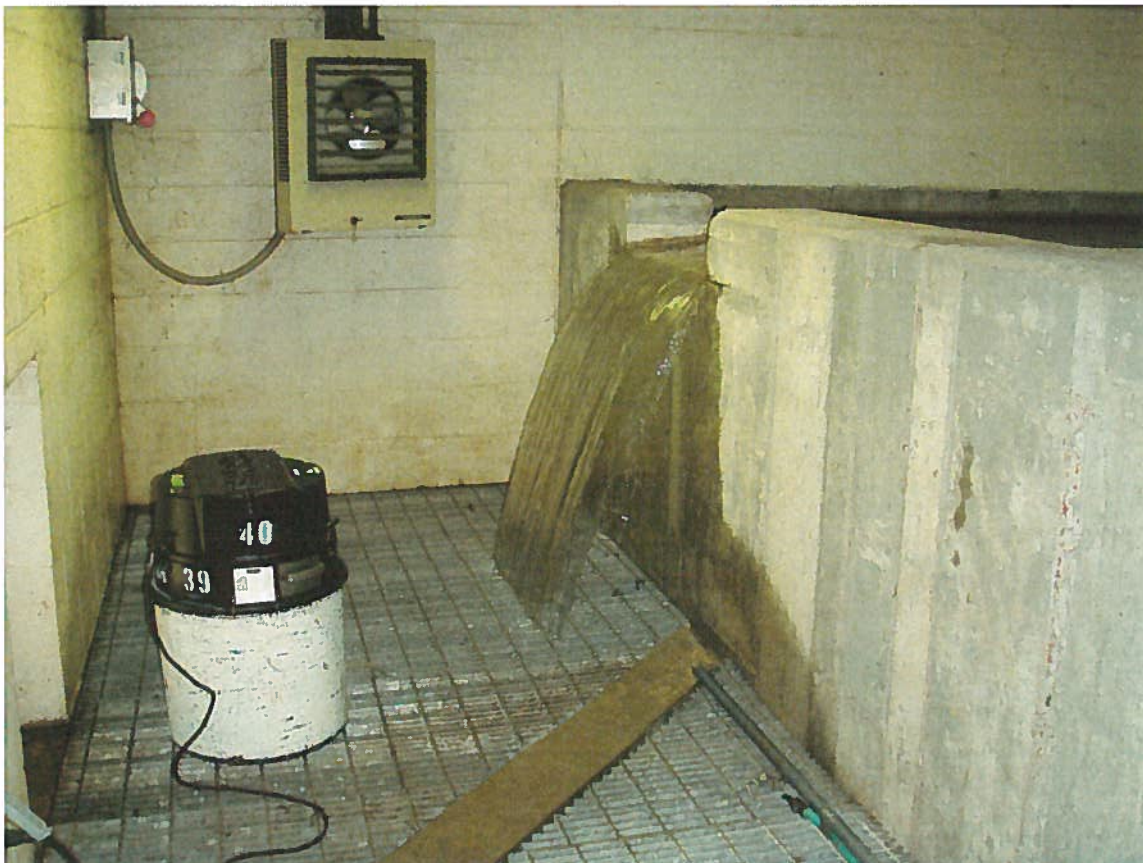
Photo no. 22 This photo was taken inside the sand filter building. The water flowing through the wall opening didn't go through the filter into the ultraviolet light disinfection channel. The flow goes directly to the facility outfall. This is a bypass since the disinfection process wasn't included as part of the treatment process.

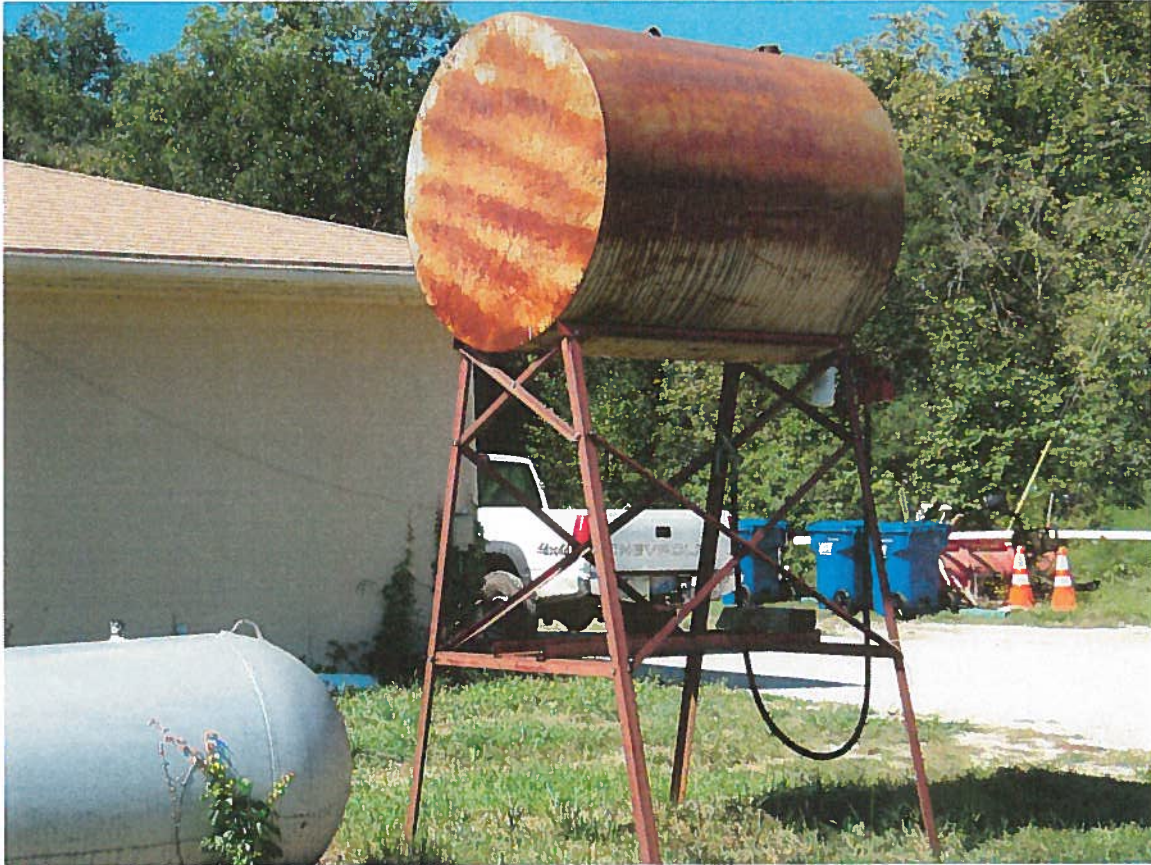
Photo no. 23 This photo was taken from the paved drying beds looking north. The building is the laboratory/control building. The elevated 500 gallon diesel fuel storage tank does not have any secondary containment.

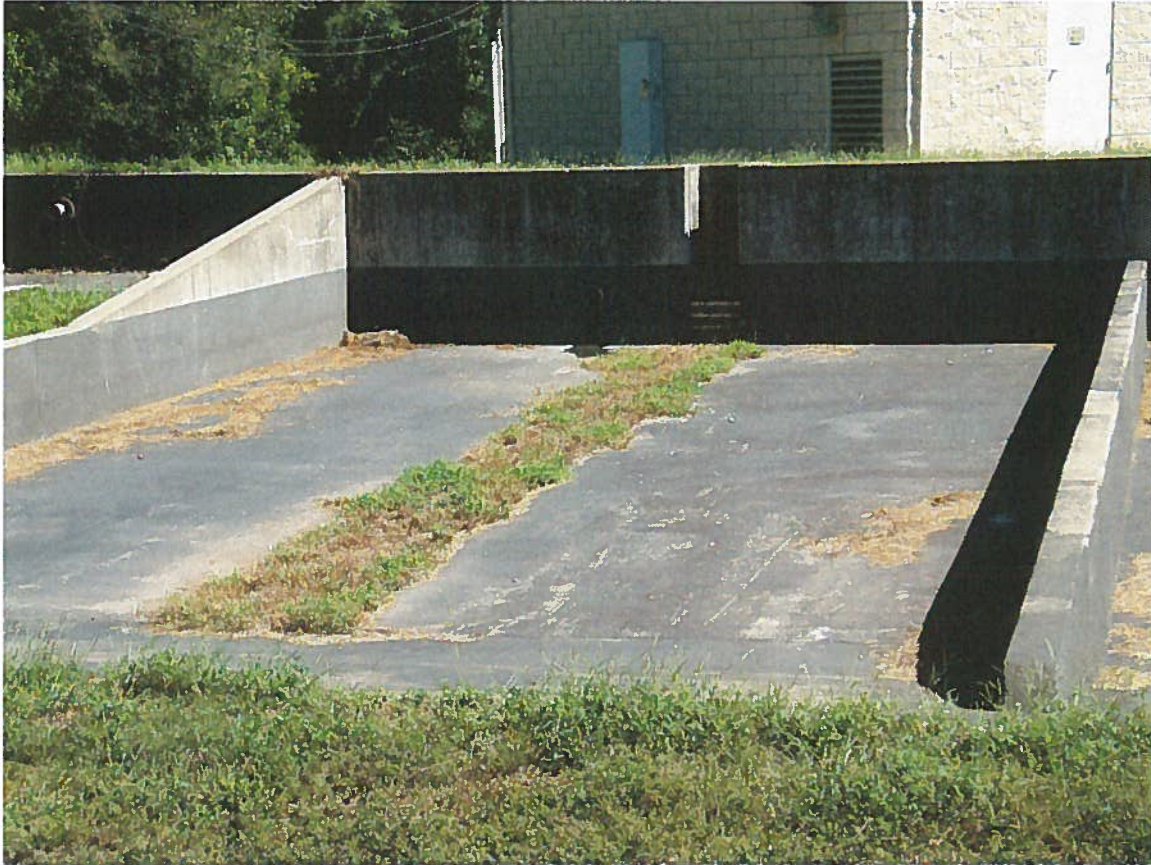
Photo no. 24 This photo was taken looking east from near the laboratory/control building. Located in the foreground are two paved drying beds. Bed drainage would be through the grassy strip in the middle of the bed. The final effluent sand filter building is located in the background.

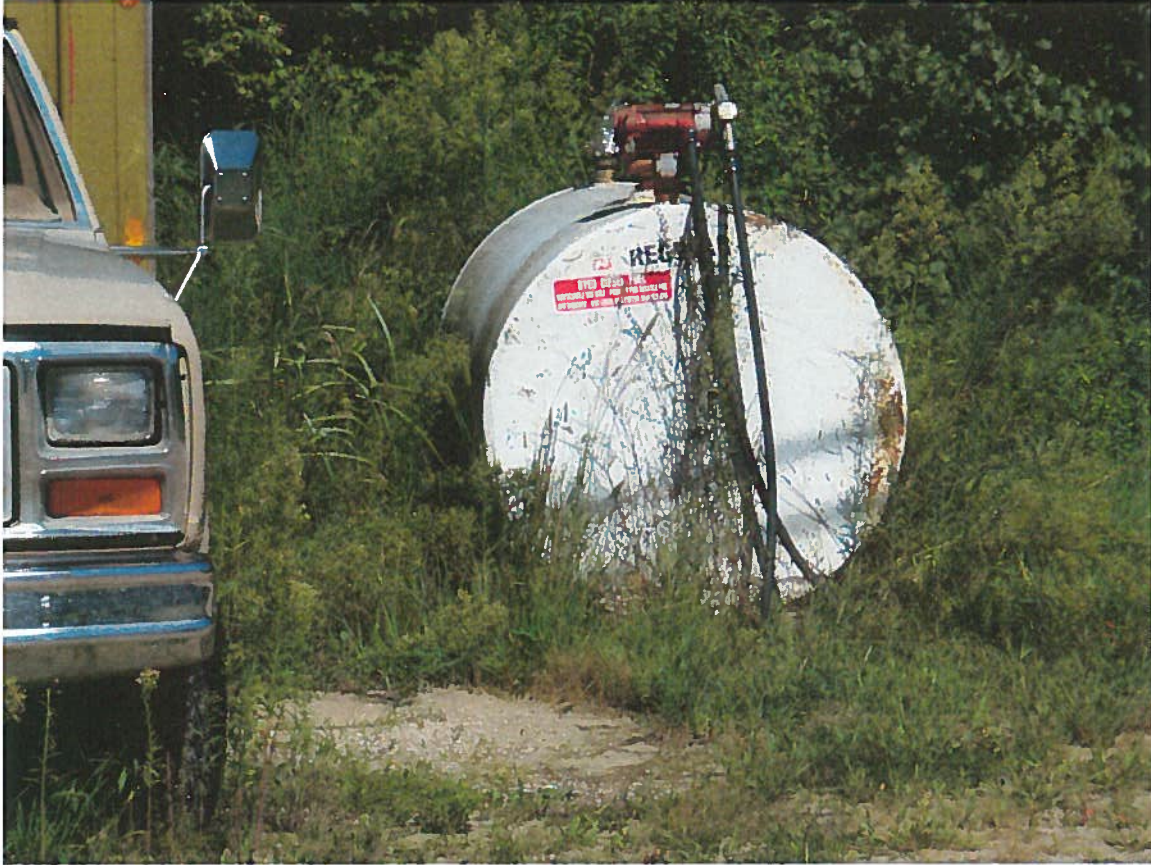
Photo no. 25 This photo was taken looking north from the parking area near the raw sewage pump building. The 300 gallon gasoline storage tank does not have secondary containment.

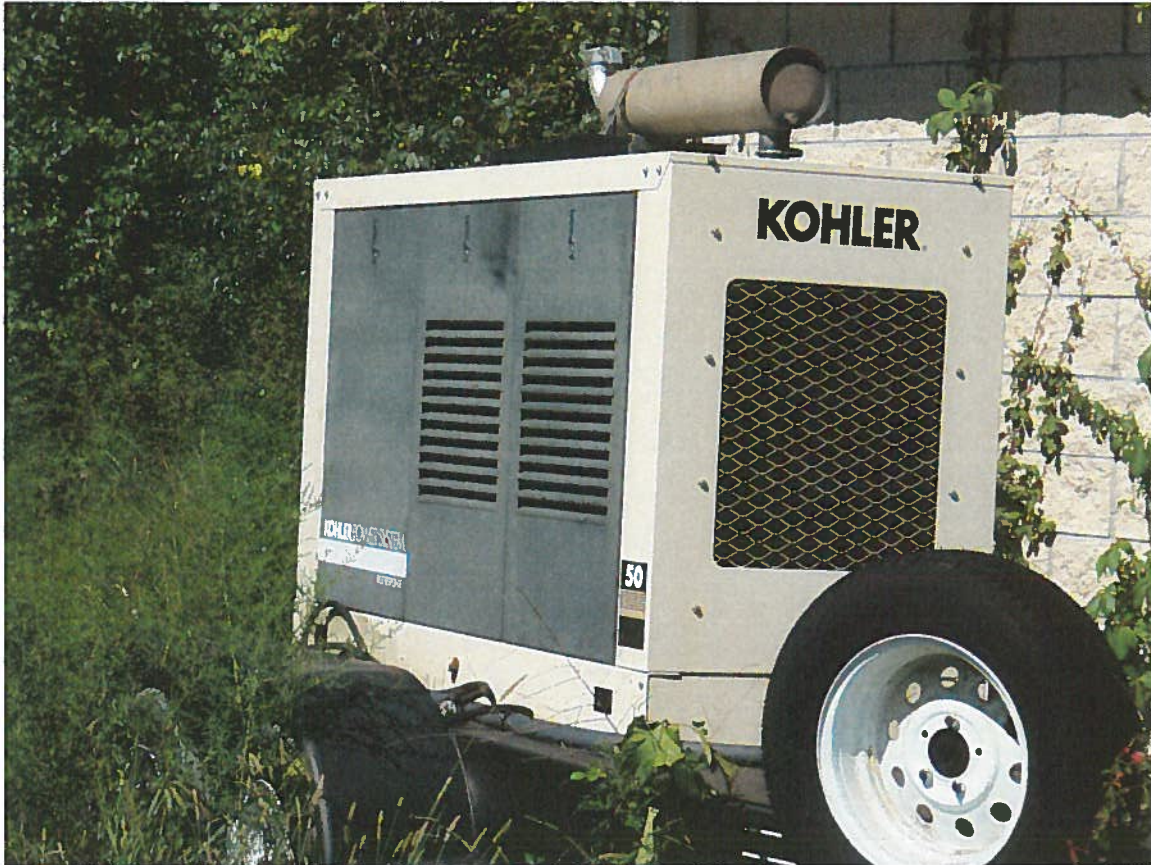
Photo no. 26 This photo was taken looking northwest from the parking area just southwest of the raw sewage pump building. Shown is a portable generator that is not used.

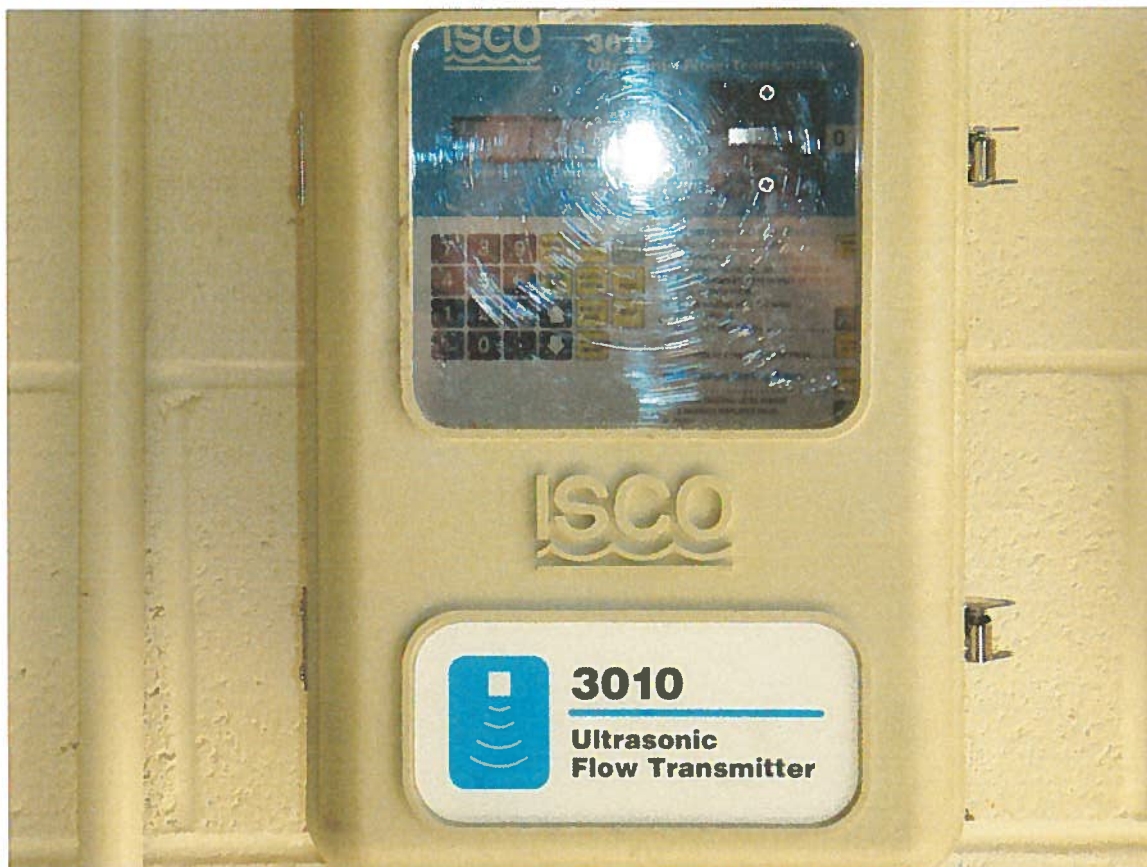
Photo no. 27 This photo shows one of several all alike flow meters used to measure flow in the plant. These meters are relatively new and should be easy to calibrate and maintain.

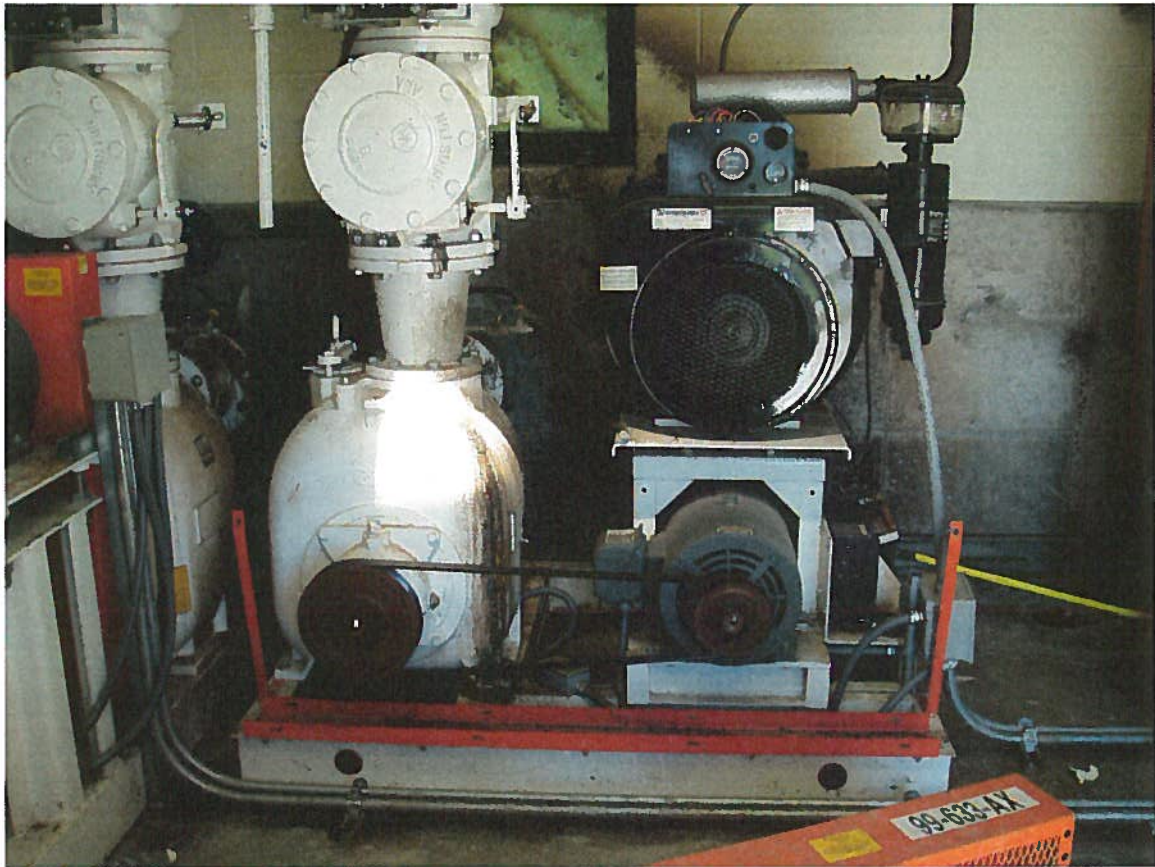
Photo no. 29 This photo was taken inside the raw sewage pump building. Shown is one of the suction lift sewage pumps. Note the missing cover over the drive belt. This is a safety hazard. This unit also has a propane operated standby generator for firm pumping capacity in the event of a power failure.

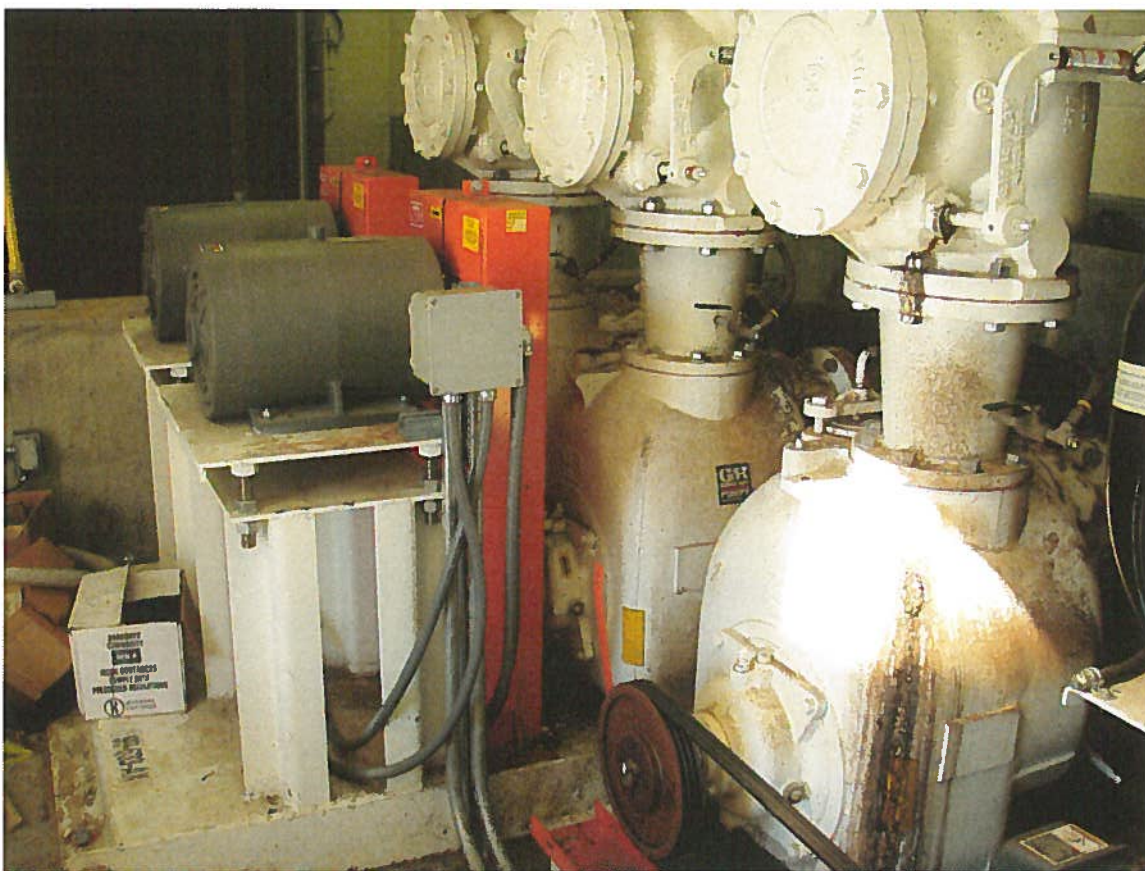
Photo no. 30 This photo was taken inside the raw sewage pump building. Shown are the suction lift sewage pumps. This building also included a chemical storage tank and feed equipment that has never been used.

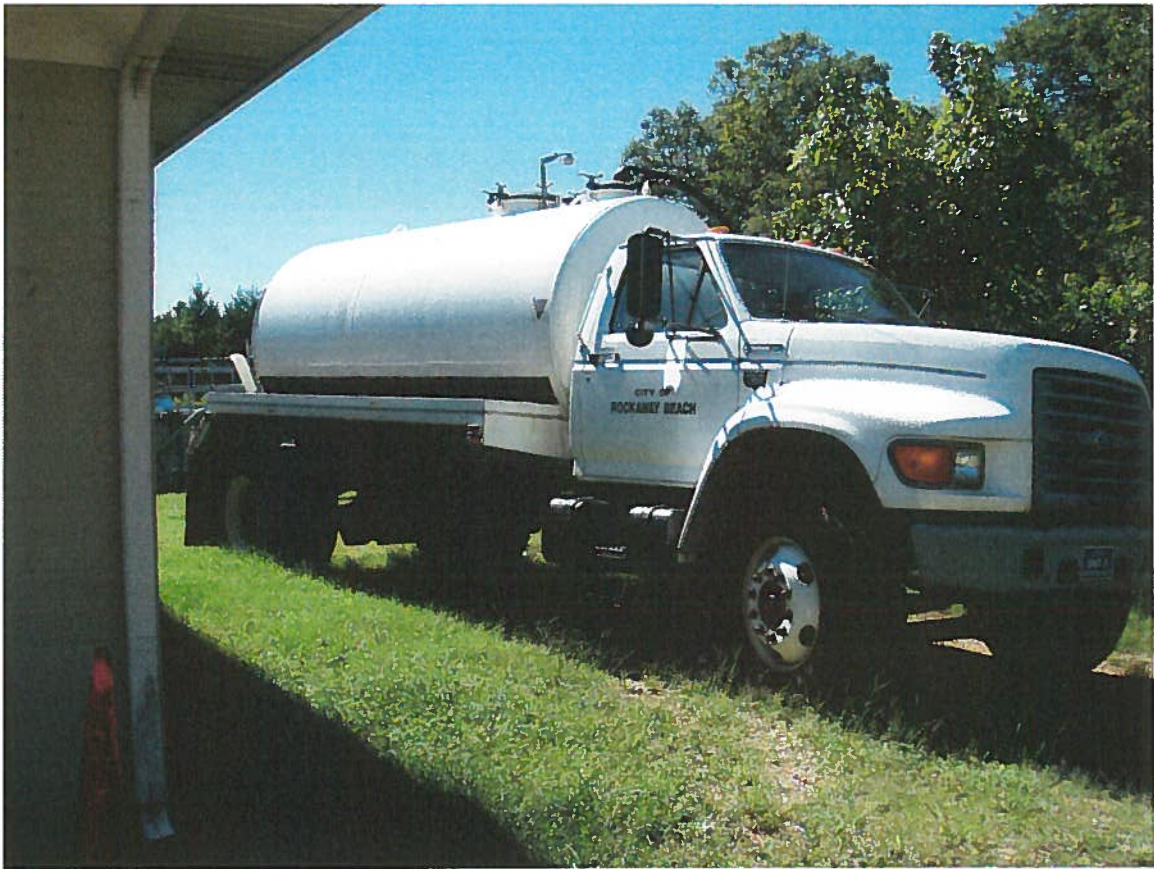
Photo no. 31 This photo shows the city's 2200 gallon liquid sludge haul truck. It is parked on the northwest side of the laboratory/control building. Much of the sludge hauled is done by a contract employee using this truck.

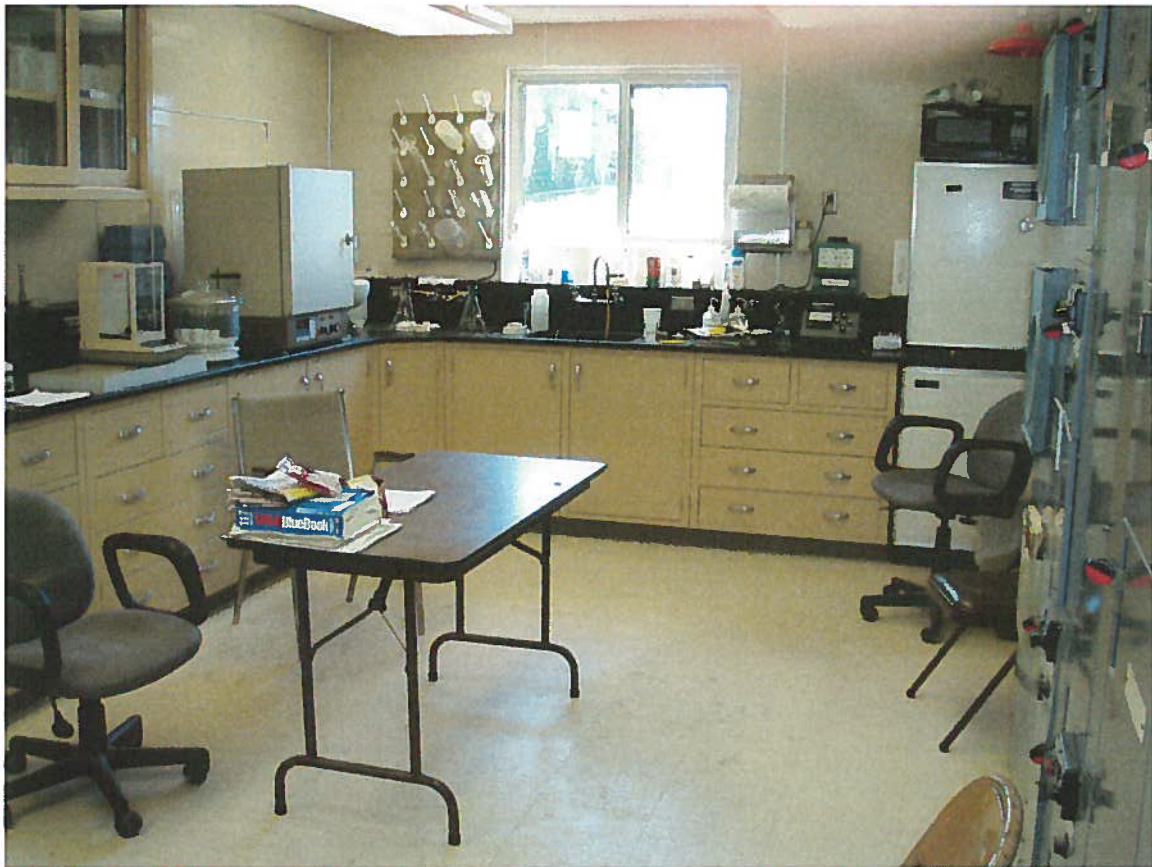
Photo no. 32 This photo shows the inside of the laboratory/control building. Commonly used laboratory testing equipment is visible. All but the dissolved oxygen meter (located underneath the time card clock) appeared to be functional.

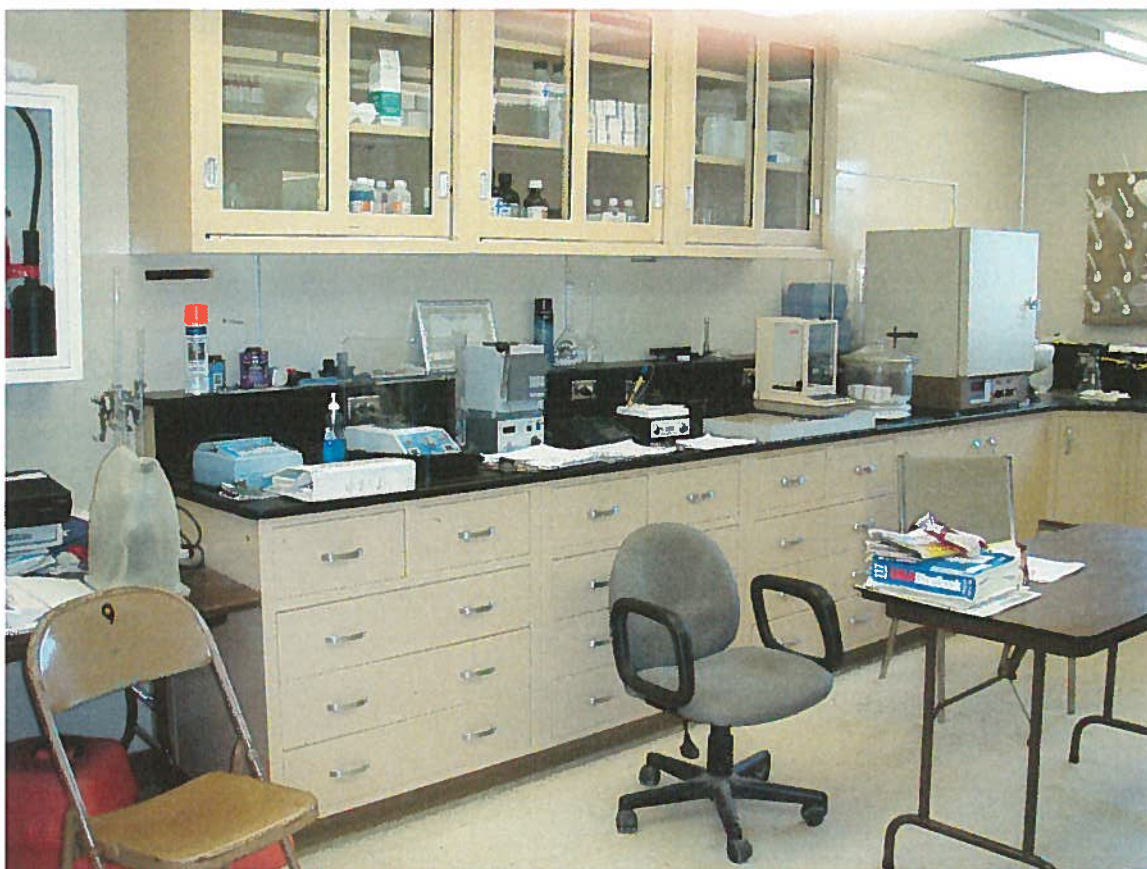
Photo no. 33 This photo shows the inside of the laboratory/control building. Commonly used laboratory testing equipment is visible. The chemicals stored in the upper cabinets were out of date (expired).

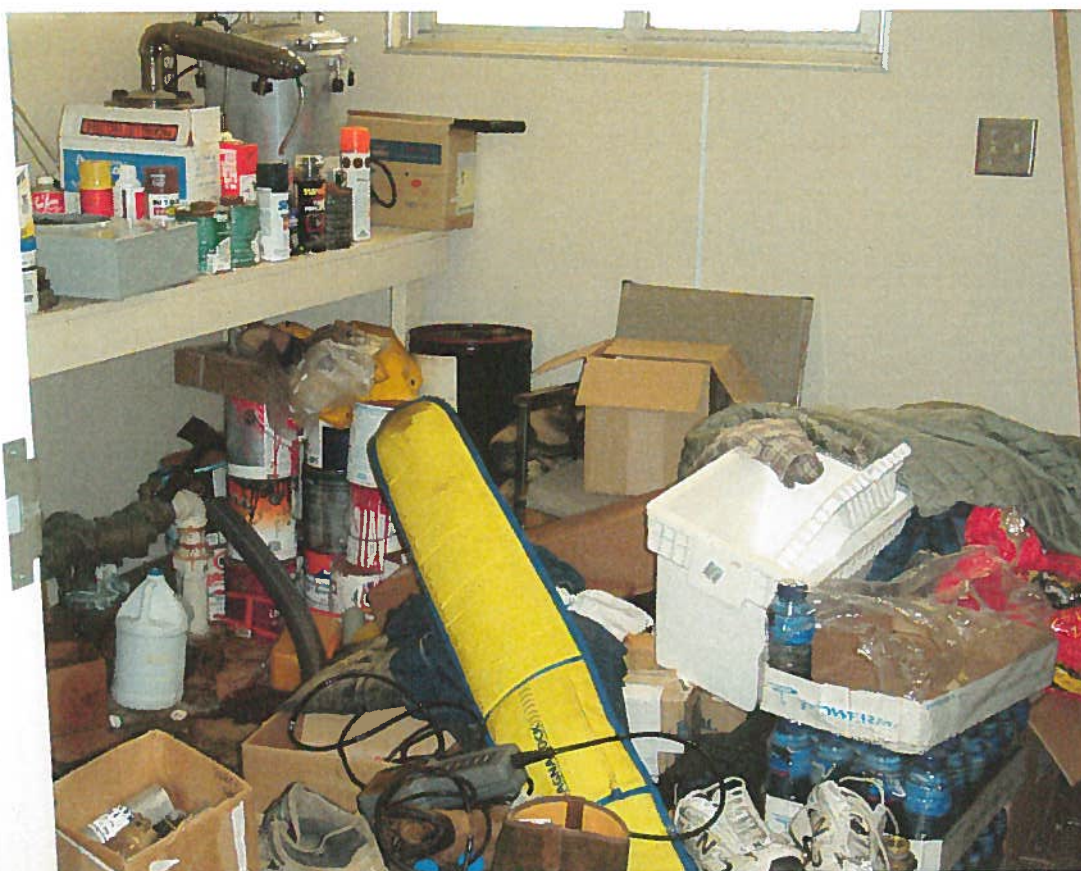
Photo no. 34 This photo shows a storage room located in the laboratory/control building. This room lacked organization and the floor clutter made moving around in the room very difficult.

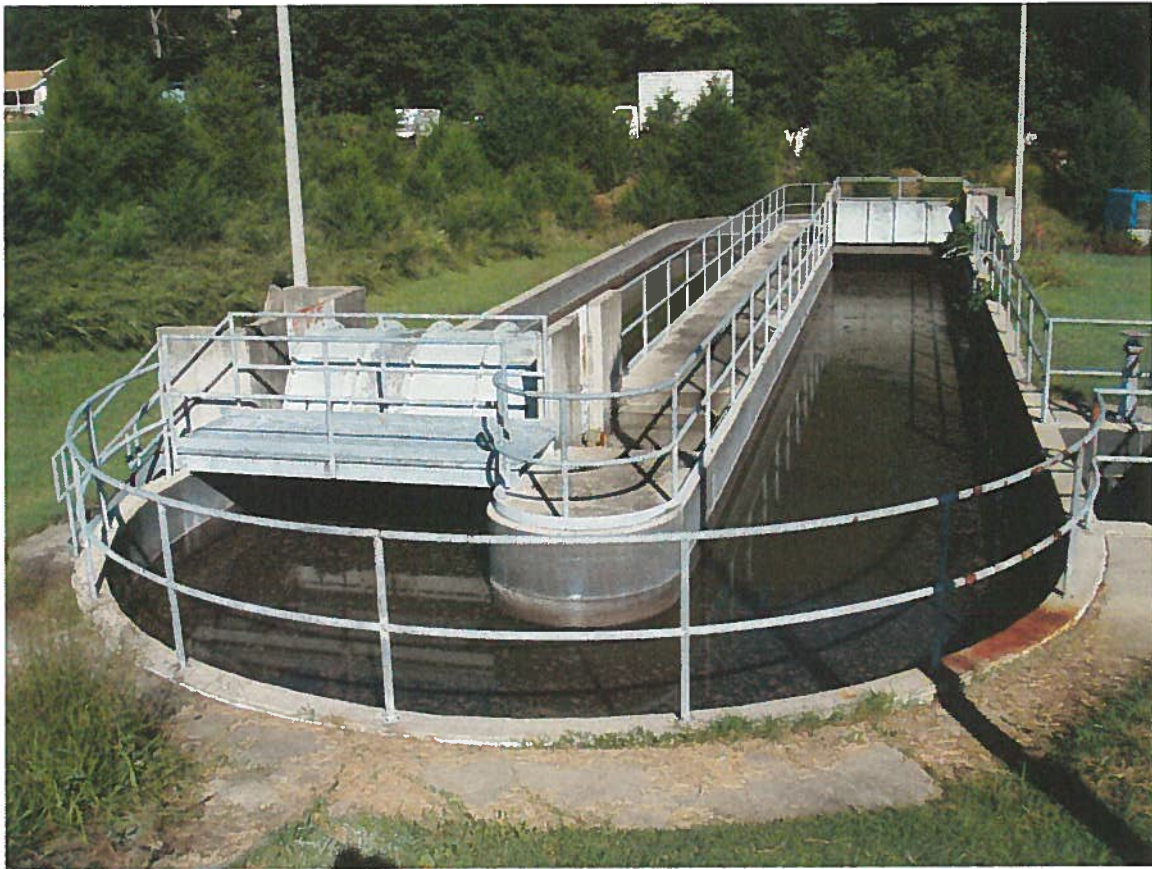
Photo no. 37 This photo looks northwest and shows the old oxidation ditch which was to be used as an aerobic digester. The design intent was to run the aerators continuously. Because of odor complaints, the rotors are not normally operated.

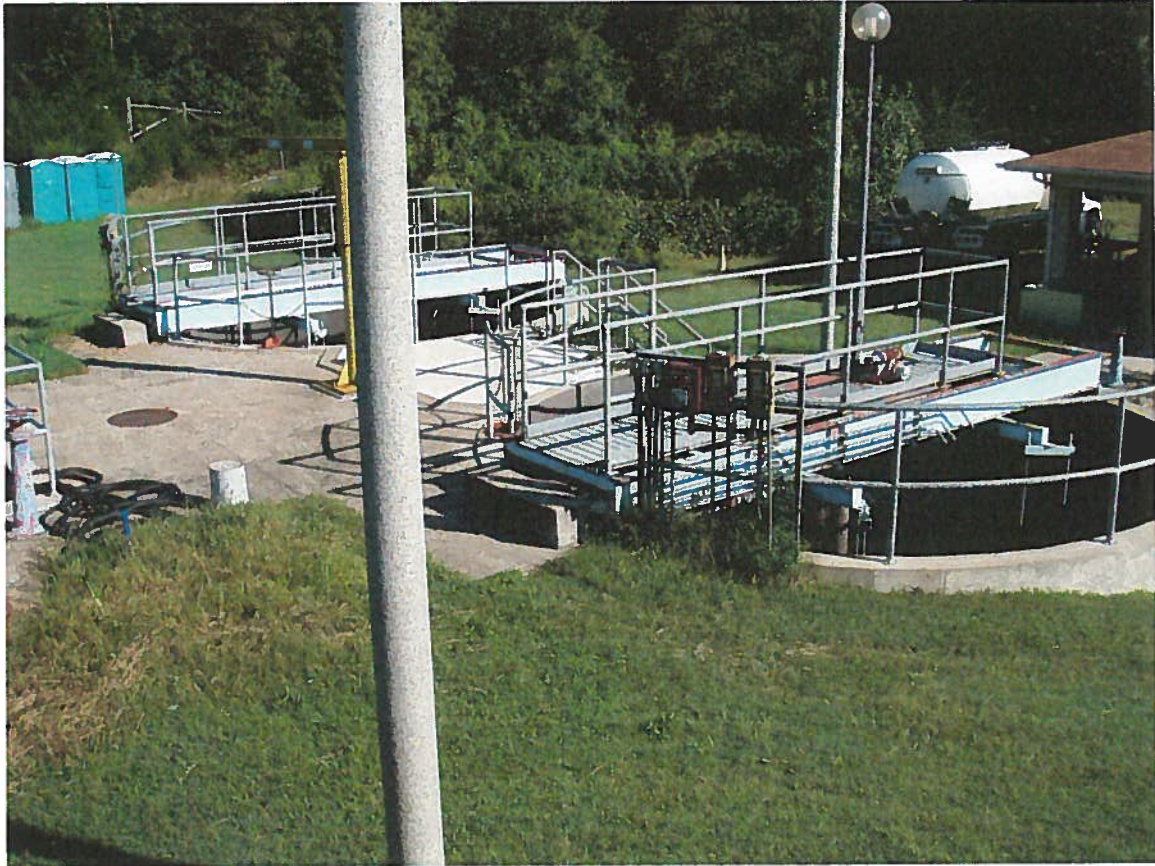
Photo no. 38 This photo was taken from the old sludge storage tank looking north. It shows the two old final clarifiers that were intended to be used as sludge thickening tanks. They are used as such with the water decanted manually using a pump. The sludge is pumped from these tanks into the liquid sludge haul truck which can be seen at the upper right.

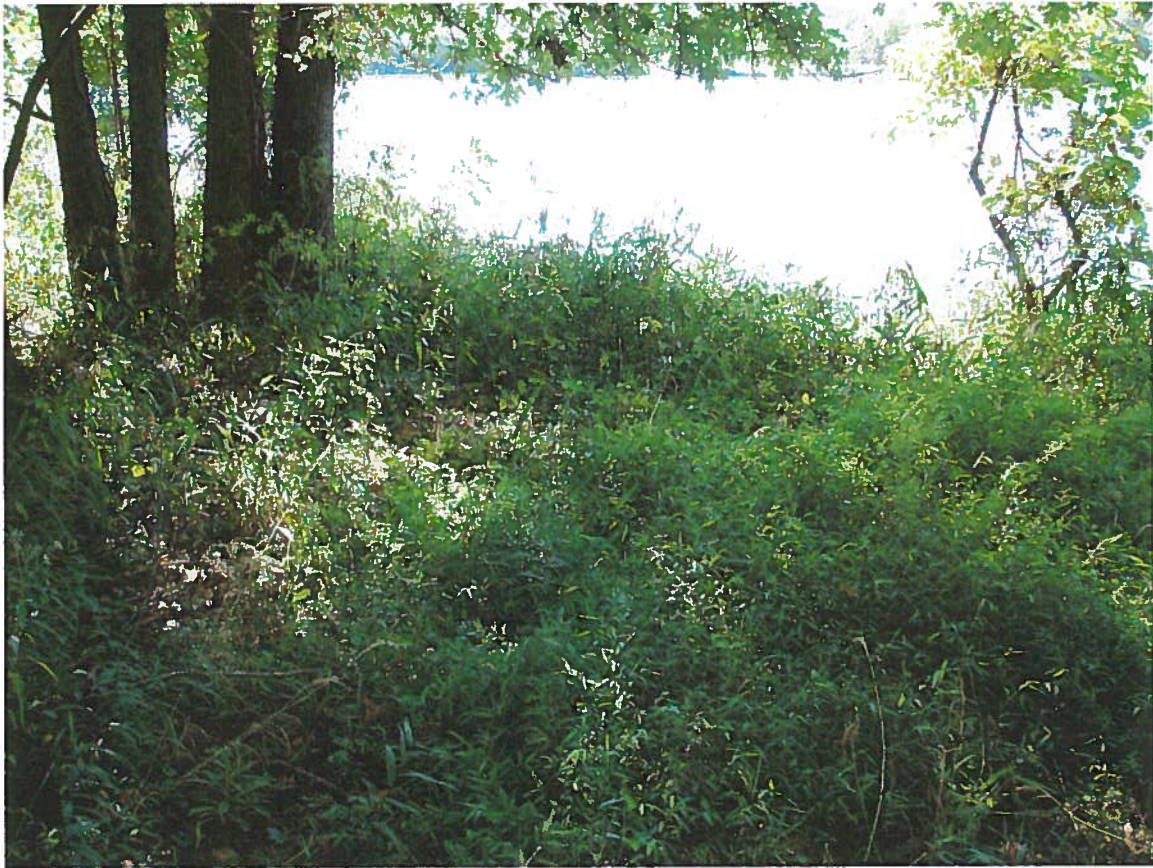
Photo no. 35 This photo looking south shows the location of the last manhole before the Lake Taneycomo submerged outfall. This would be the location of a visible sign designating the outfall as required by the NPDES permit.

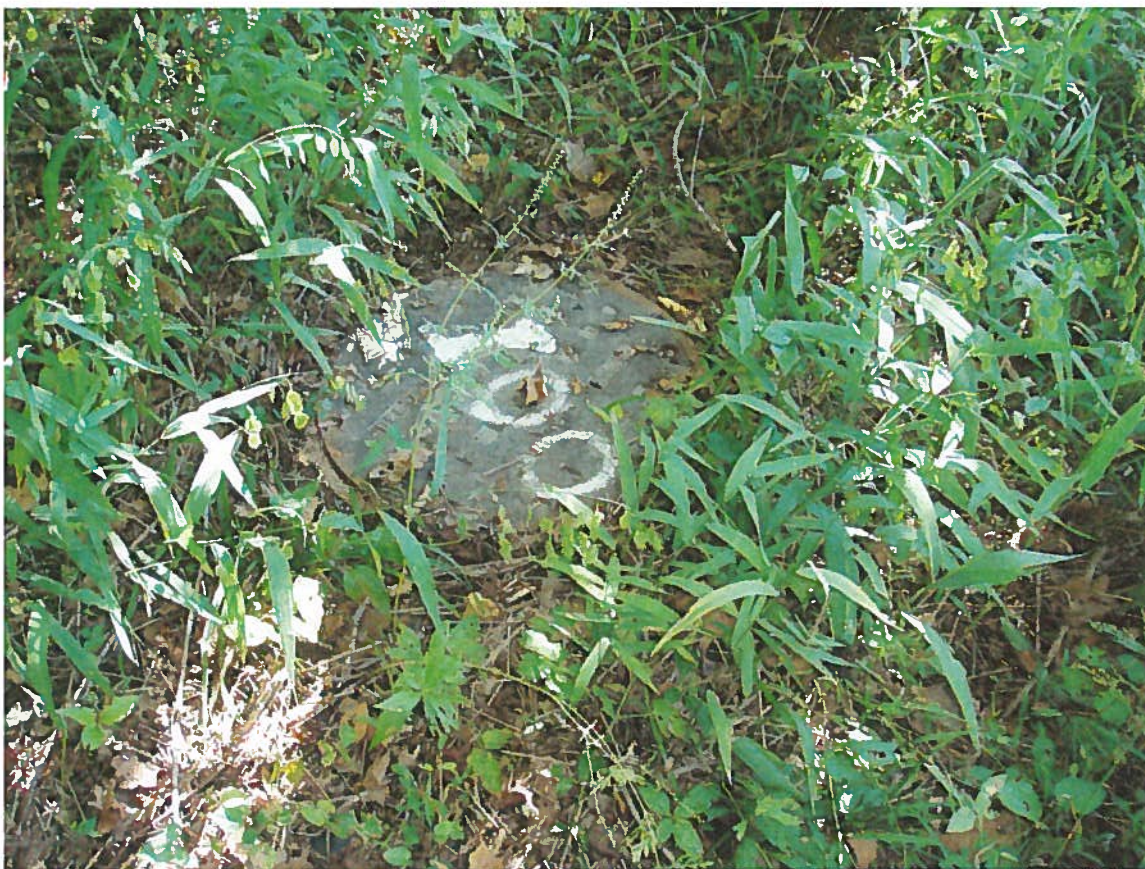
Photo no. 36 This photo shows the location of the last manhole before the Lake Taneycomo outfall. This would be the required location of a visible sign designating the outfall as required by the NPDES permit. Instead, the location is marked with an "001" indicating outfall 001 which has no real meaning to local citizens.

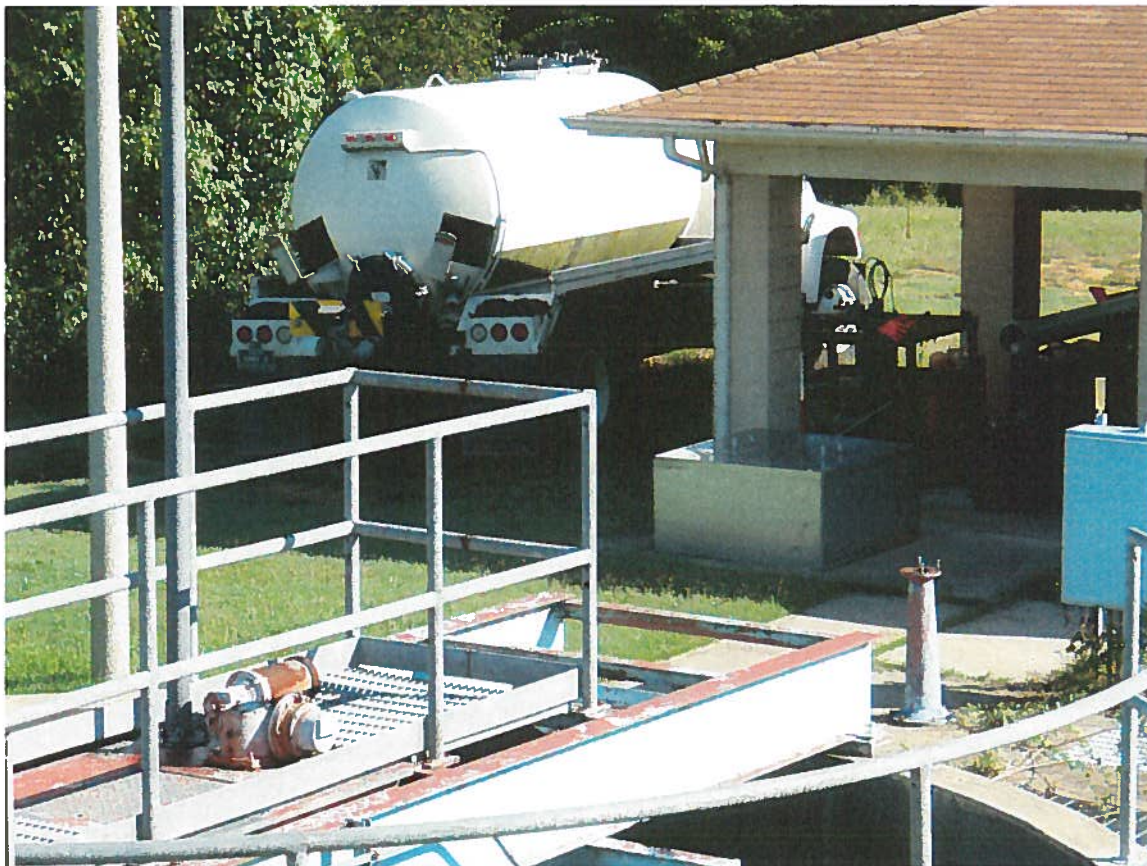
Photo no. 39 This photo was taken from the old sludge storage tank looking north. It shows one of the old final clarifiers in the foreground and the liquid sludge hauling truck in the upper center of the photo. The truck applies the sludge by spray bar.

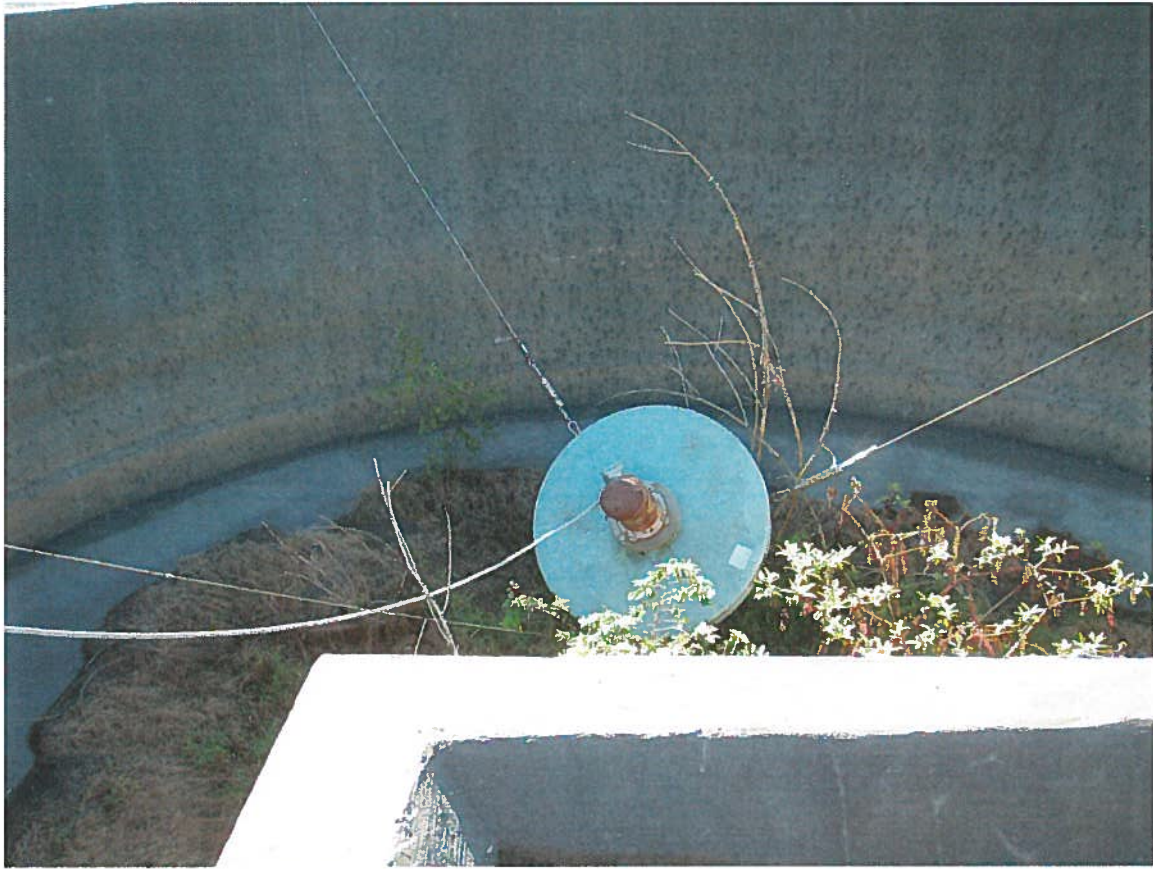
Photo no. 40 This photo was taken from the top of the old sludge storage tank. The vegetation growing in the bottom of the tank is good evidence that the tank is not used for gravity thickened sludge storage. The floating aerator is visible in the bottom of the tank.

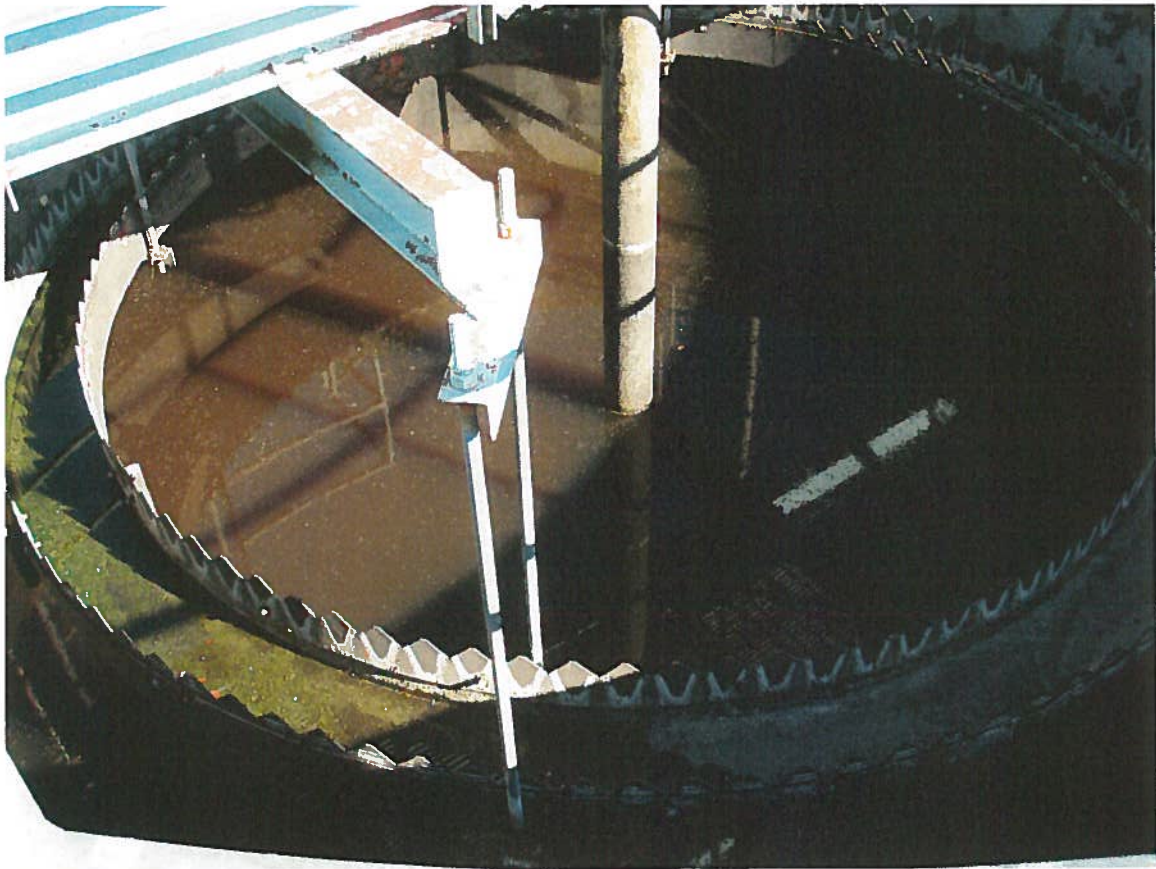
Photo no. 41 This photo was taken from the top of one of the old final clarifiers. The visual appearance of the clarifier suggests that it is not being used as a gravity sludge thickening unit but more as a storage basin.

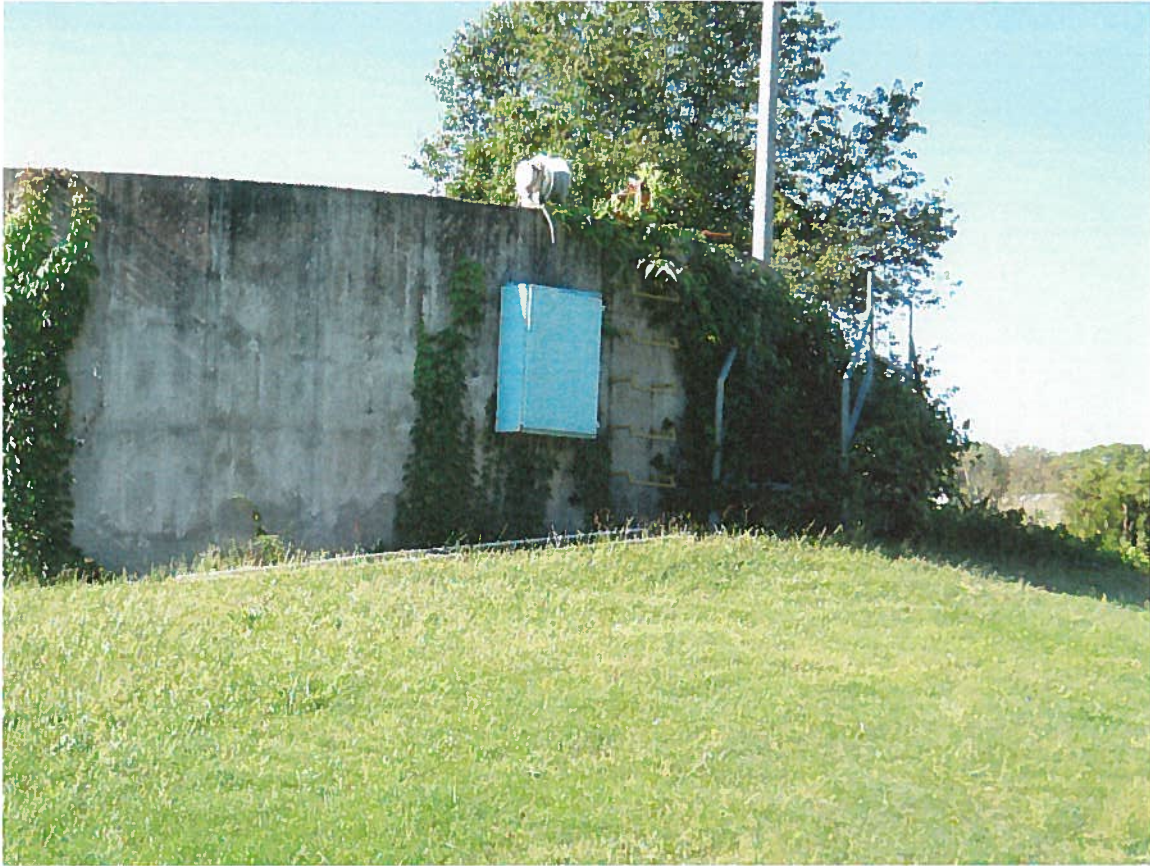
Photo no. 43 This photo was taken from near the new treatment tanks looking west at the old sludge holding basin. The access stairs have grown up in vines that limit access to the unit. Access is not an operator concern since he doesn't use the tank for sludge storage.
